ANNUAL REPORT FOR 2015

Holland Creek Site M Mitigation Site
Madison County
TIP No. R-2518A
COE Action ID: SAW-2007-2197-357/300
DWR #: 20071134

Prepared By:
Natural Environment Section & Roadside Environmental Unit
North Carolina Department of Transportation
November 2015

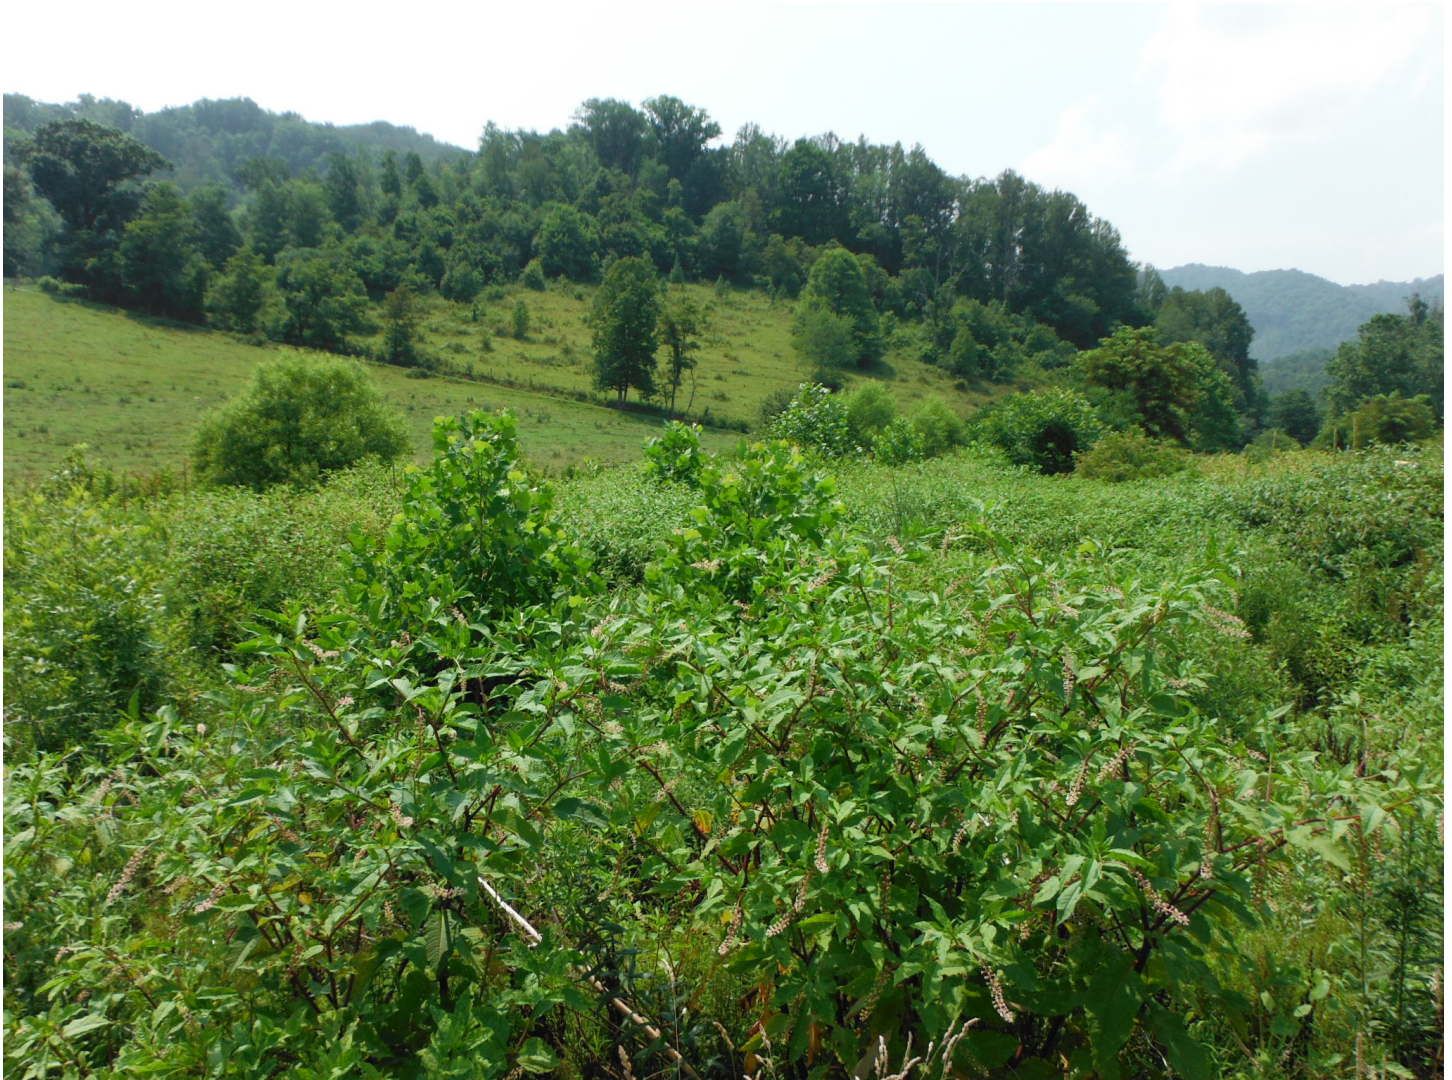
Vegetation Overview Photo

Streambank & Buffer Vegetation: The streambank reforestation was completed in March 2012. NCDOT completed a supplemental planting of the northeast buffer in March 2015 to increase plant survival in this area. The Year 4 vegetation monitoring evaluation noted: Type I: Black Willow, Silky Dogwood and Type II: Sycamore, Green Ash, White Oak and Tulip Poplar were surviving throughout the site.
